**Technical Report 1628**  
September 1993

# **Dynamic and Static Exposure Tests and Evaluations of Alternative Copper-Based Antifoulant Coatings**

E. Lindner

**NAVAL COMMAND, CONTROL AND  
OCEAN SURVEILLANCE CENTER  
RDT&E DIVISION  
San Diego, California 92152-5001**

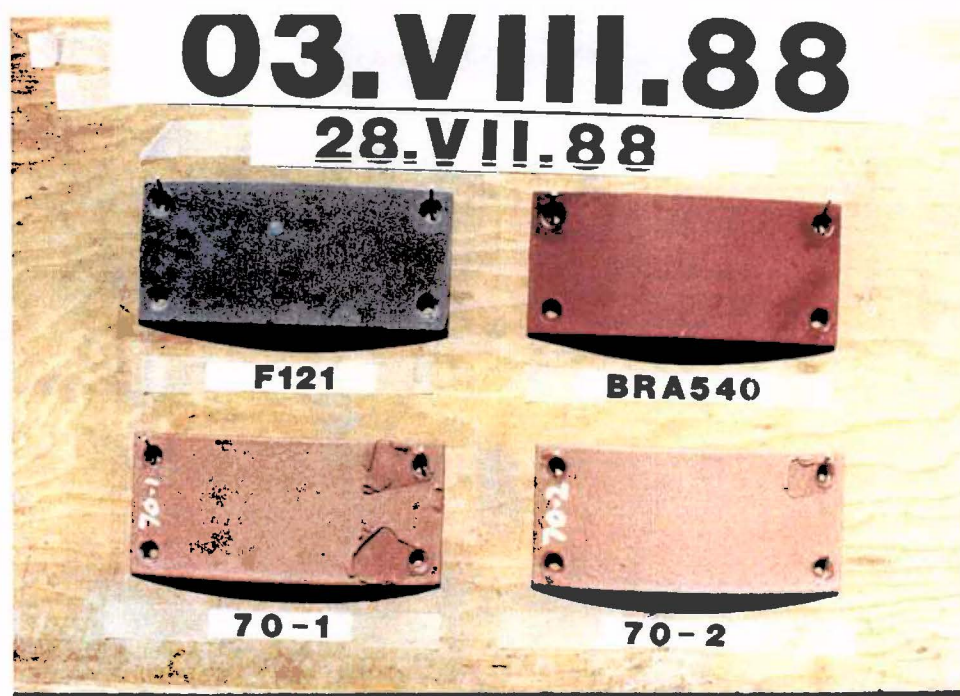
The dynamic exposure test of Ameron 70 was discontinued after the first month because about 50% to 100% of the top layer (AF) stripped off from all four panels (figures 12 and 13). This failure may have resulted from insufficient curing time before exposure to high currents. To allow for curing while stationary, a new set of panels was exposed at the beginning of the static cycle on 27 February 1989 (table A-6). For control, F121 was exposed at the same time. Simultaneously, two panels coated with Ameron 70 were exposed for static conditions (table A-17).

Figure 12. The top layer began peeling off at the corner holes of both Ameron 70 panels after only 4 days of dynamic exposure.
